**Federal Aviation
Administration**

ADVISORY CIRCULAR

AVIATION MAINTENANCE ALERTS

**ALERT
NUMBER
362**

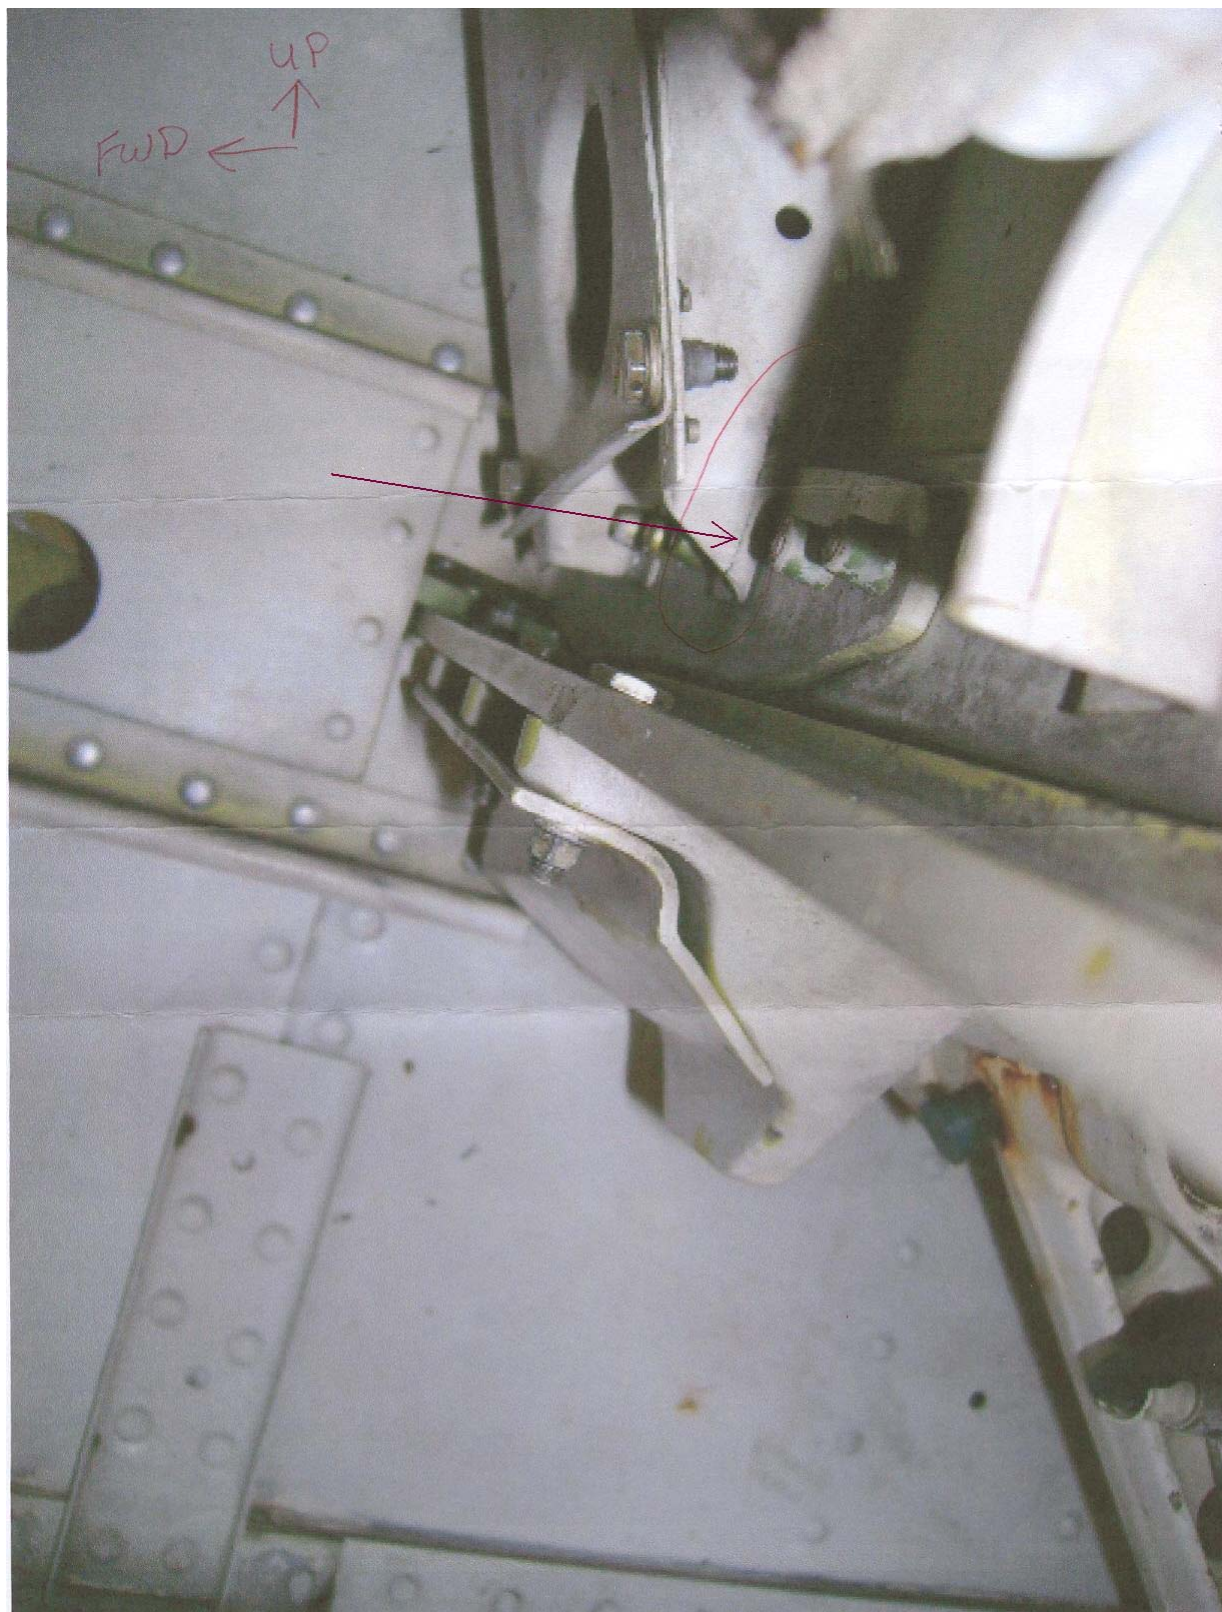
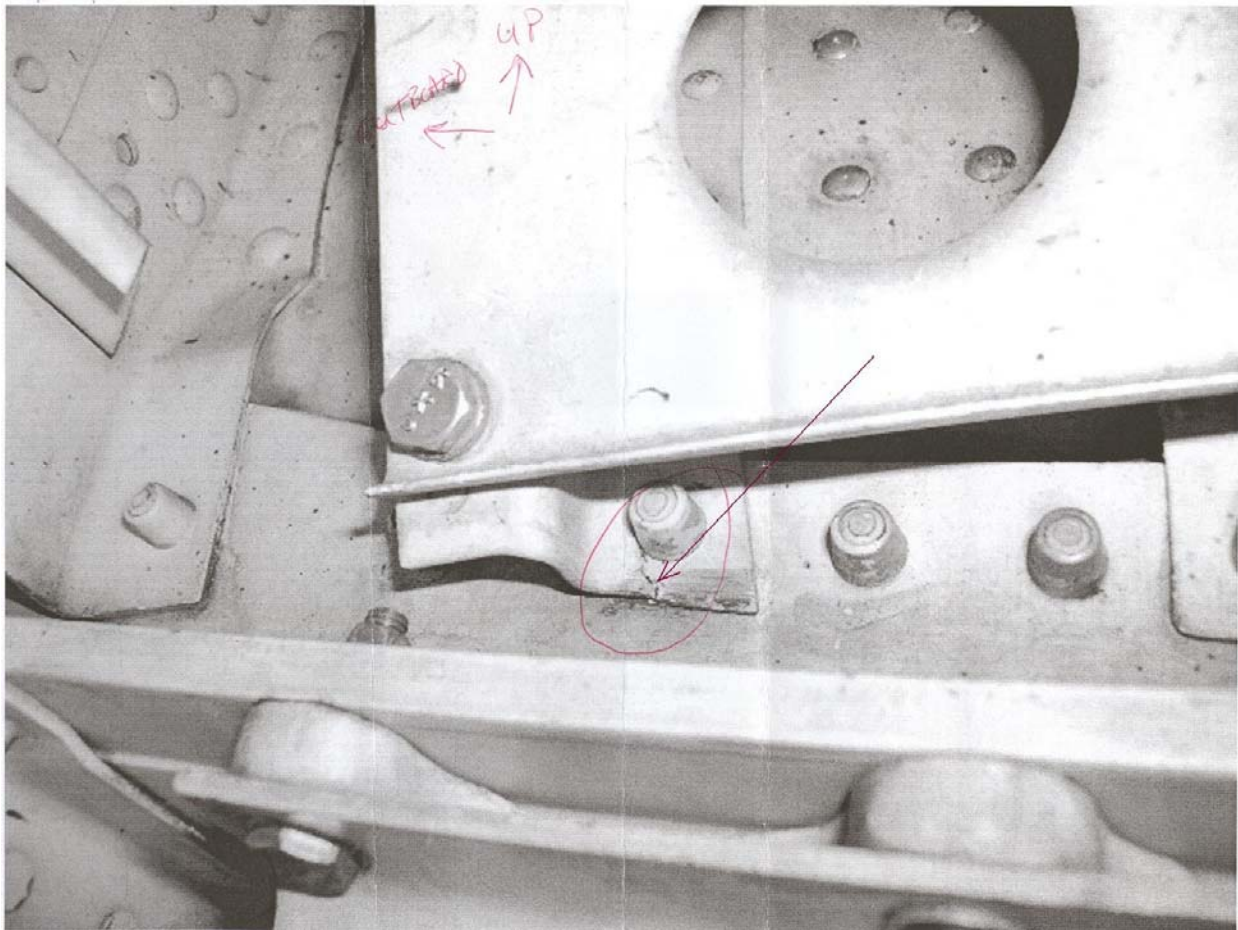
Beech: C90; Cracked Drag Leg Support Brackets; ATA 5740

A repair station technician states, "The drag leg support brackets (*P/N 50-120077-16 & -17*) were found cracked on both left and right sides during a routine inspection. (*These*) cracks are most likely (*caused*) by fatigue or a rough landing."

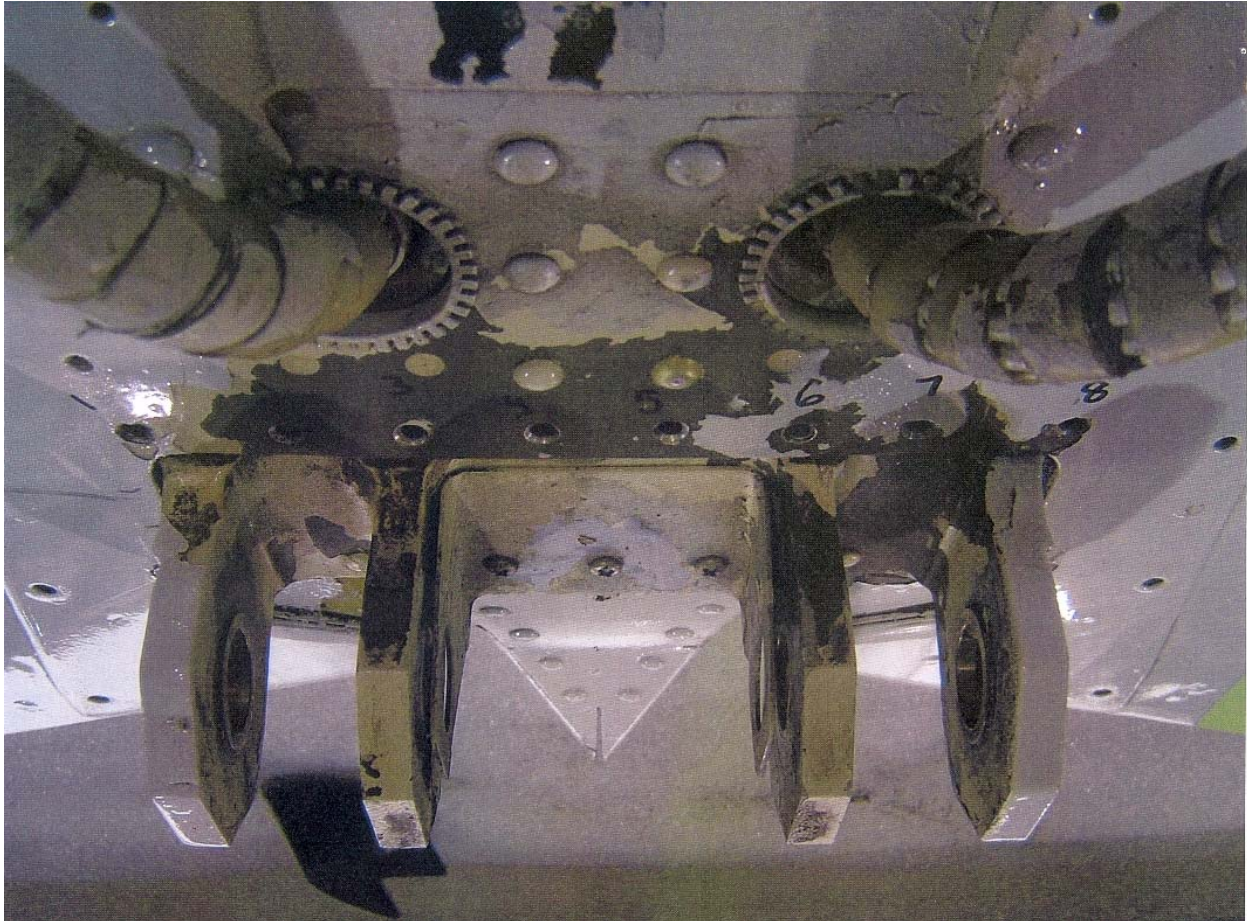
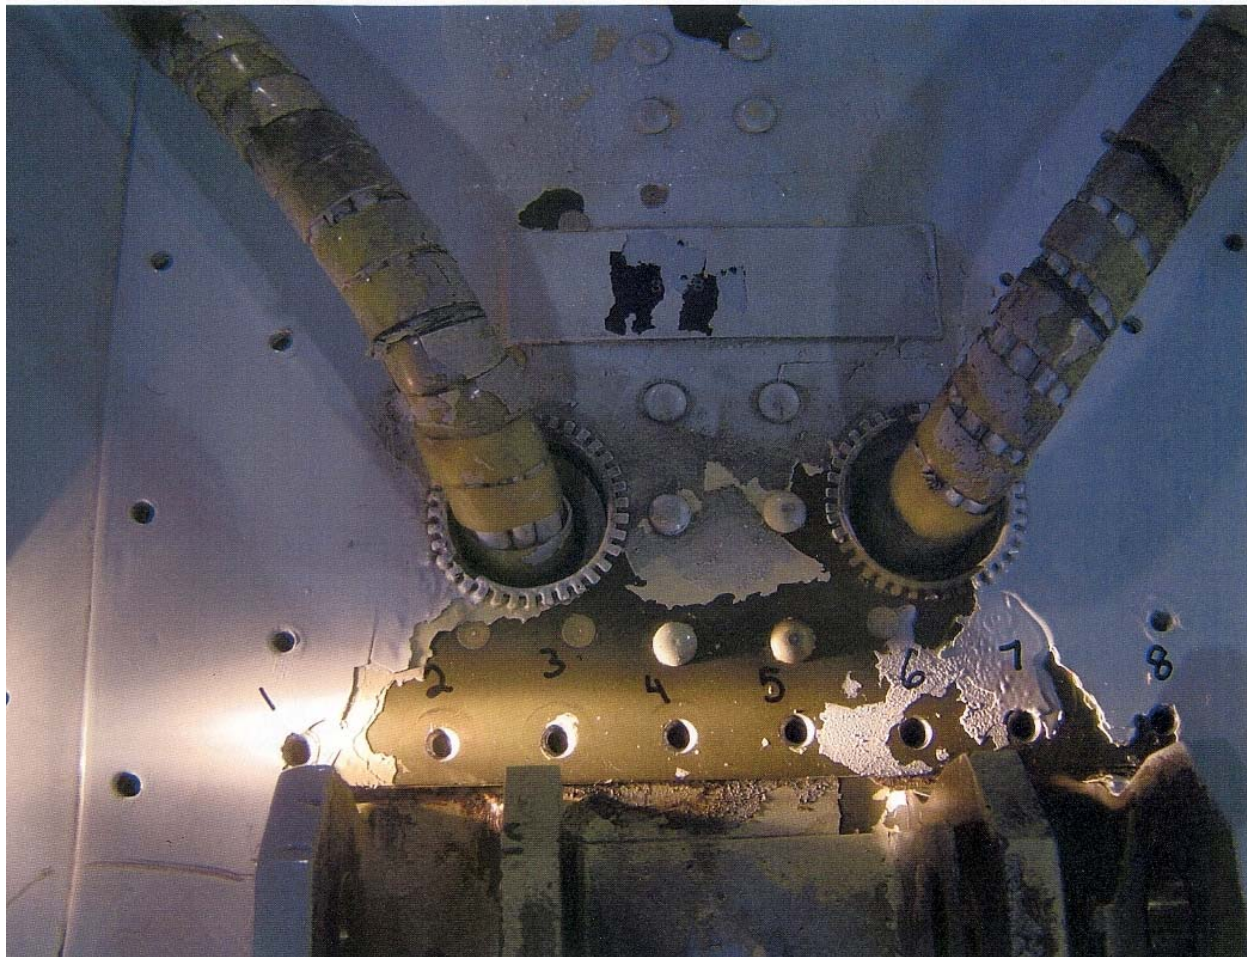
“While performing a scheduled A-D inspection, eight sheared rivets were found in the forward rivet line of the attachment pivot fitting (P/N 45A21183-11) on the bottom of the horizontal stabilizer. It is suspected the missing rivets failed from fatigue. Recommendations are to inspect this area thoroughly at each inspection and to contact Hawker Beechcraft for repair options.” *(Horizontal stabilizer P/N 45A21002-41.)*

(Aircraft total cycles: 5,867. See similar defect further down. This particular N-numbered aircraft has an additional defect report—next.)

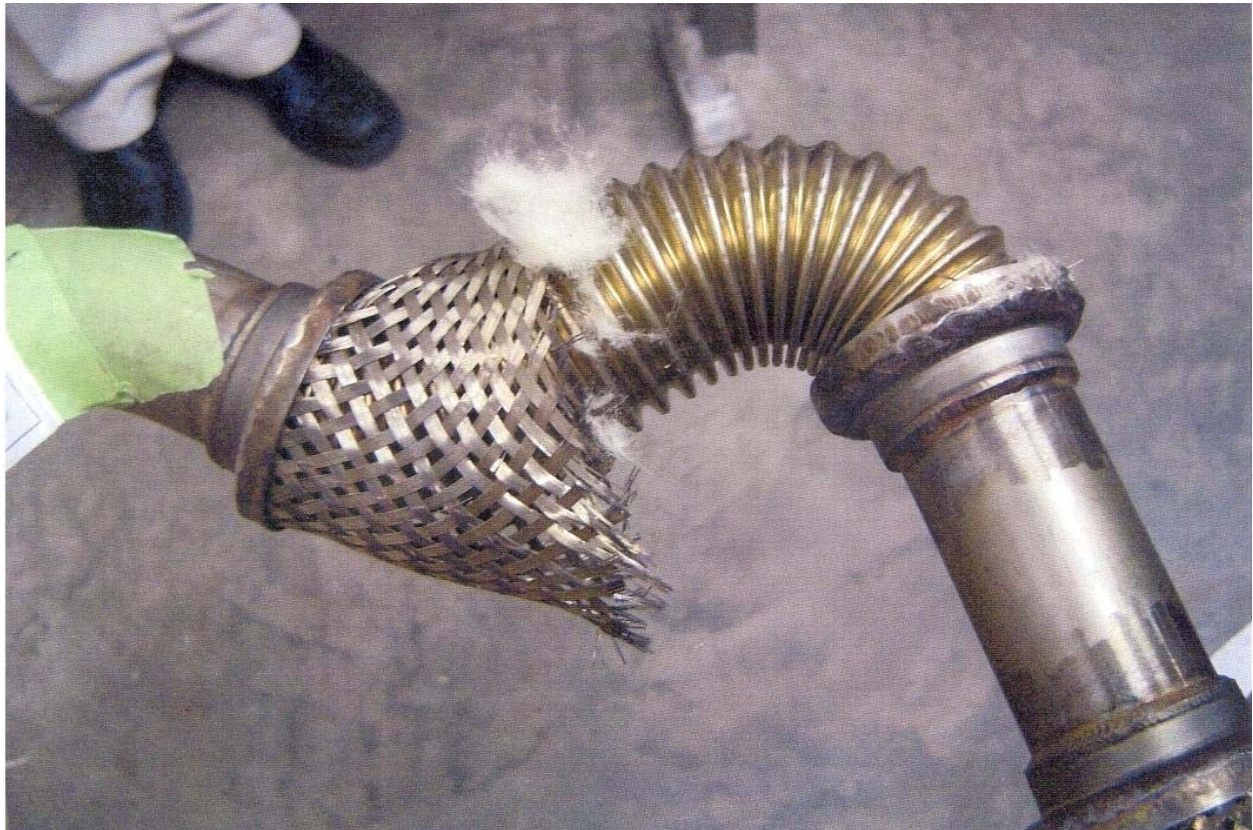
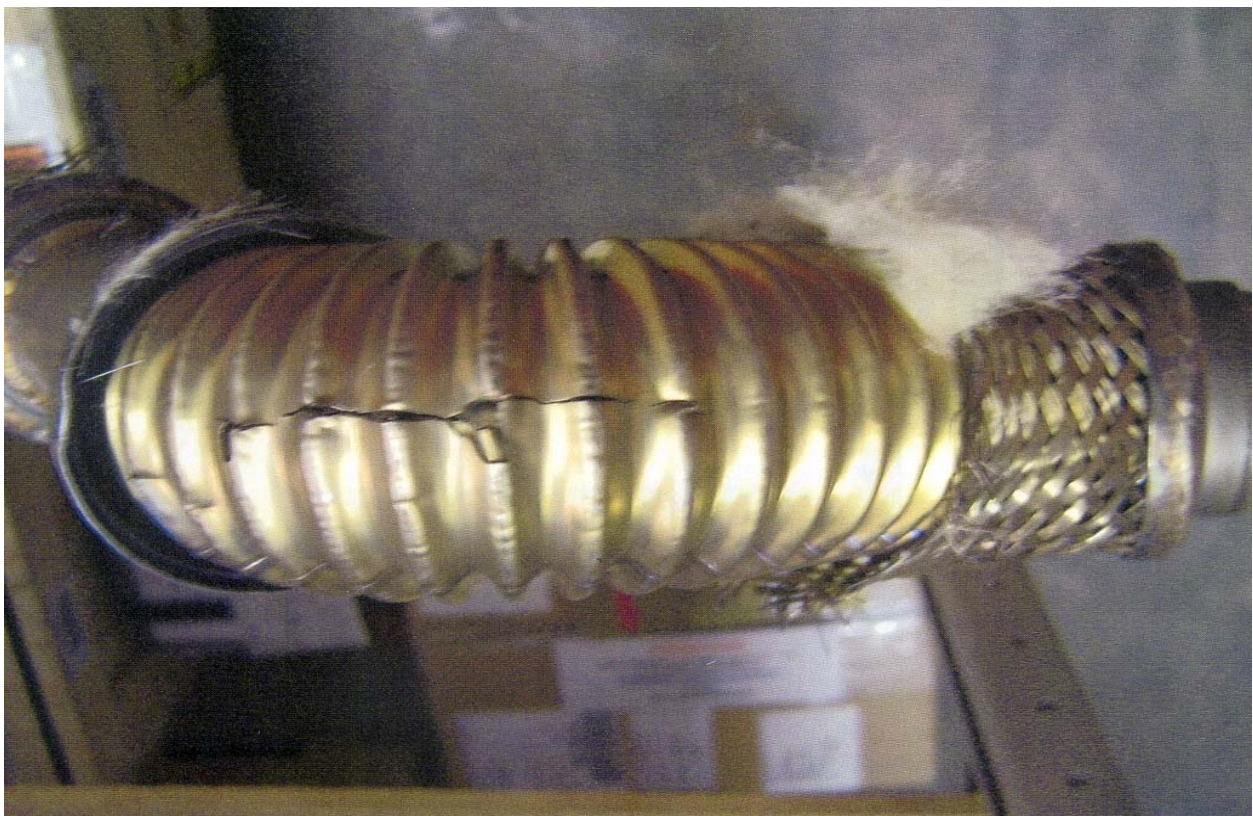
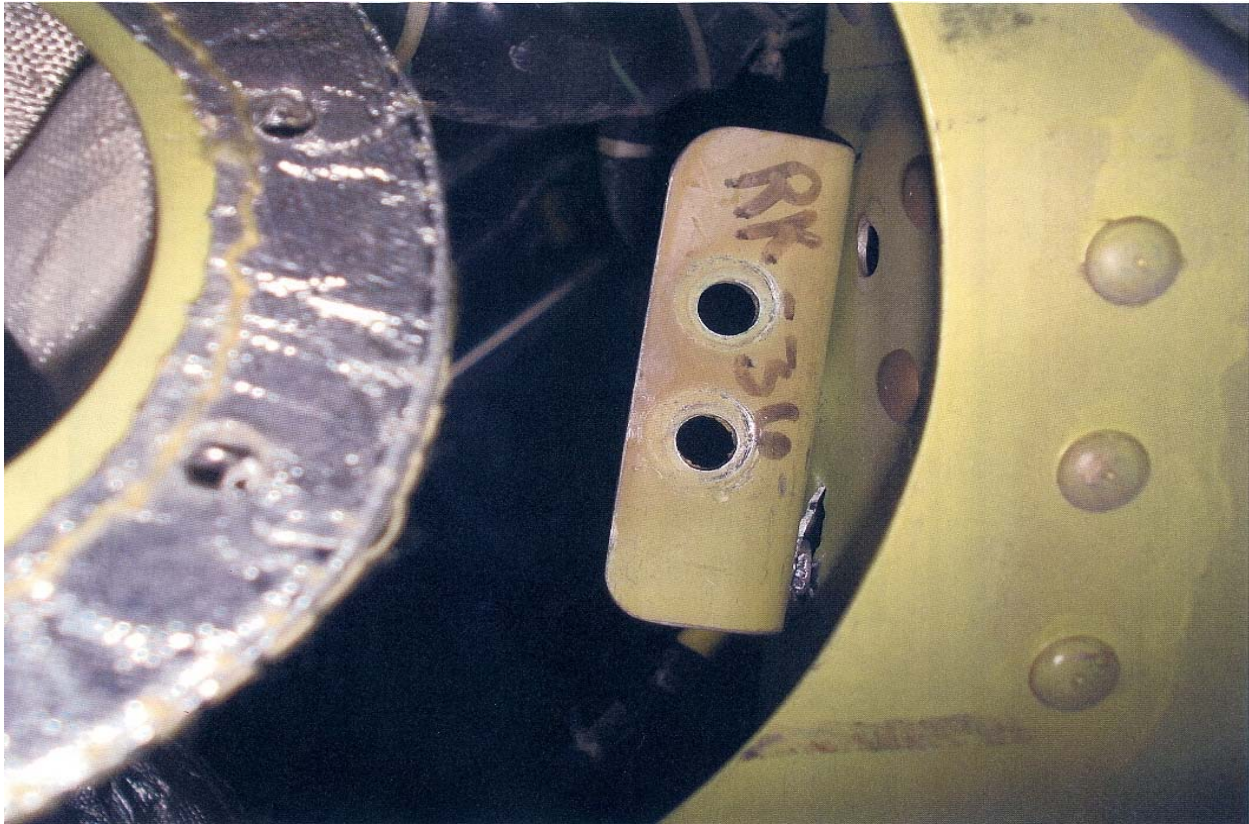
Our technician states, “While performing a scheduled A-D inspection, the left aft fuselage bleed air line bellows (P/N 45A63517-073) was found blown apart. The right aft fuselage bleed air line bellows-braiding (P/N 45A63517-075) was found fraying. When the left bleed air line blew apart it cracked a fuselage bulkhead at upper frame station 329.92 and BP 29.92L. I would recommend that detailed inspections of these bleed air lines be performed at scheduled intervals, and the upper frame station in the areas around the bleed air lines be carefully inspected for damage. It is suspected both bleed lines failed due to fatigue or time in service.

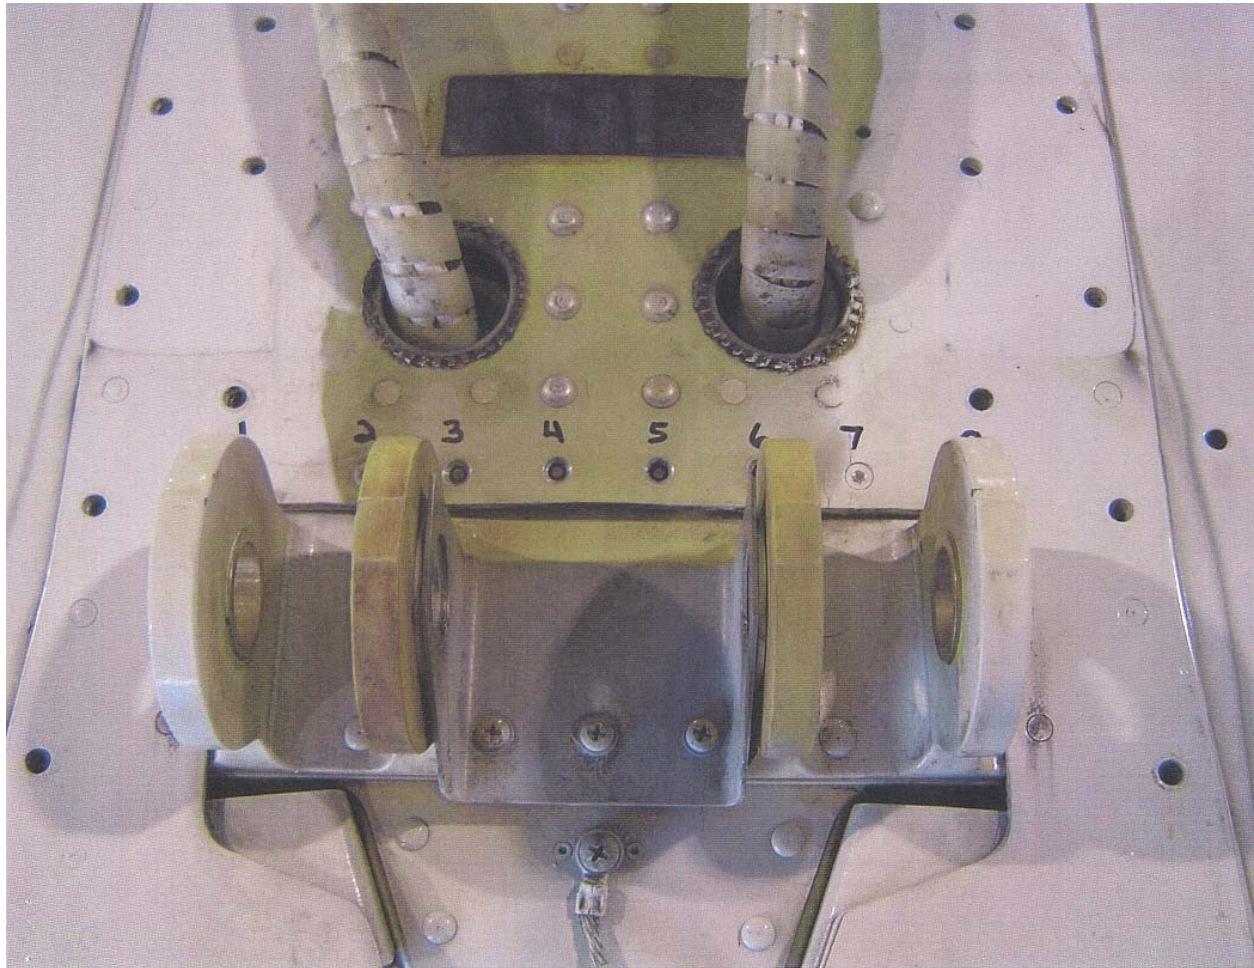
“While performing a scheduled A-D inspection, six sheared rivets and two loose rivets were found in the forward rivet line of the attachment pivot fitting (P/N 45A21183-11) on the bottom of the horizontal stabilizer. It is suspected the missing rivets failed from fatigue. Recommendations are to inspect this area thoroughly at each inspection and to contact Hawker Beechcraft for repair options. This is the second aircraft this same discrepancy has been found.”

(Horizontal stabilizer P/N 45A21002-91; note this number slightly different from the previous stabilizer number. Aircraft total cycles: 4,331.)

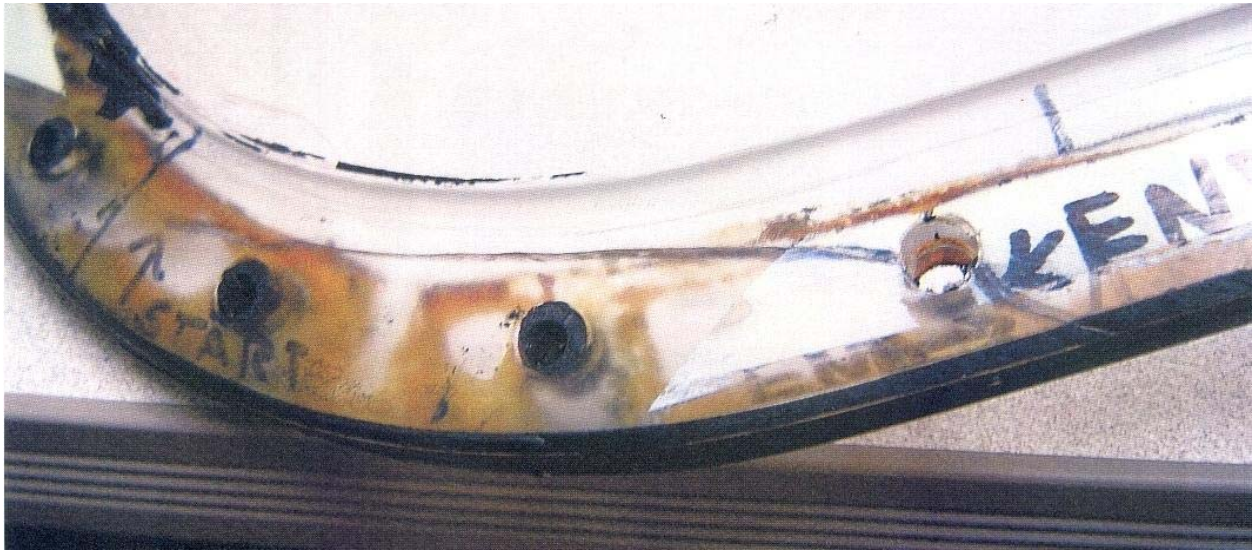
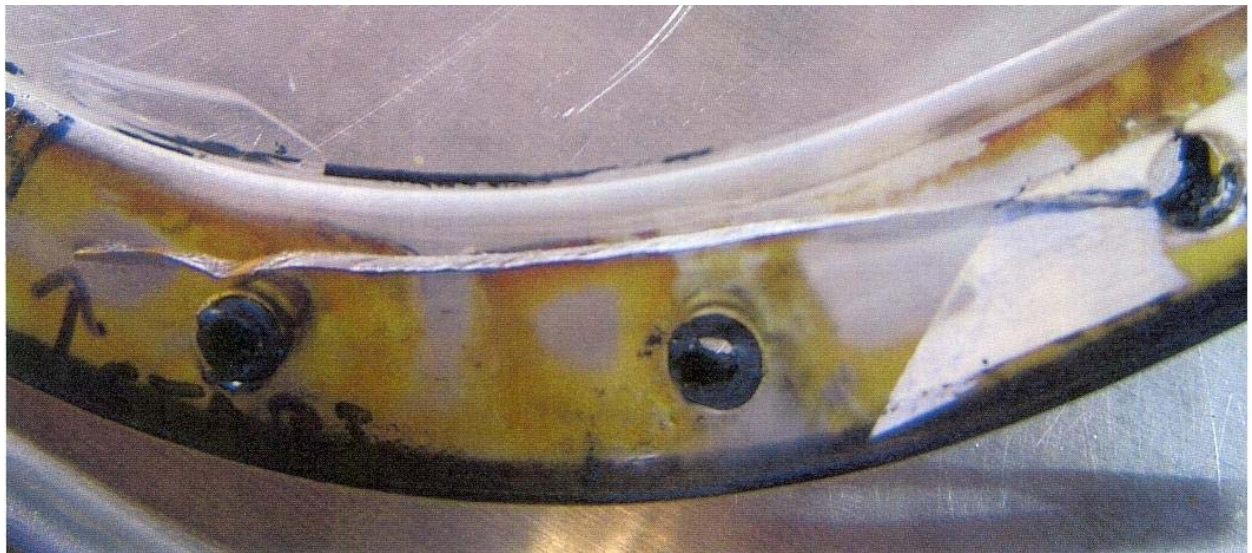
“While performing a scheduled A-D inspection, I found the copilot’s cockpit side window cracked using the prism inspection method. The ‘D’ inspection requires both windshields be inspected by removing the windshield retainers or using optical prism inspection (*criteria*). There is no statement in the aircraft or in the A-D inspection checklist that requires one to inspect the cockpit side windows in the same manner as the windshields. All of the windows in the cockpit area are installed or fastened in the same manner as the windshields. It is suspected the copilot side window cracked from fatigue, or total time installed. This window was manufactured in May of 1997. It is recommended inspections of all cockpit windows with a prism be completed at scheduled intervals.”

(Copilot side window P/N 45AS31010-12. Aircraft total cycles: 4,331; aircraft total time: 4,730.0 hours. Good advice, sir. Thank-you for your efforts and detailed photographs—Ed.)

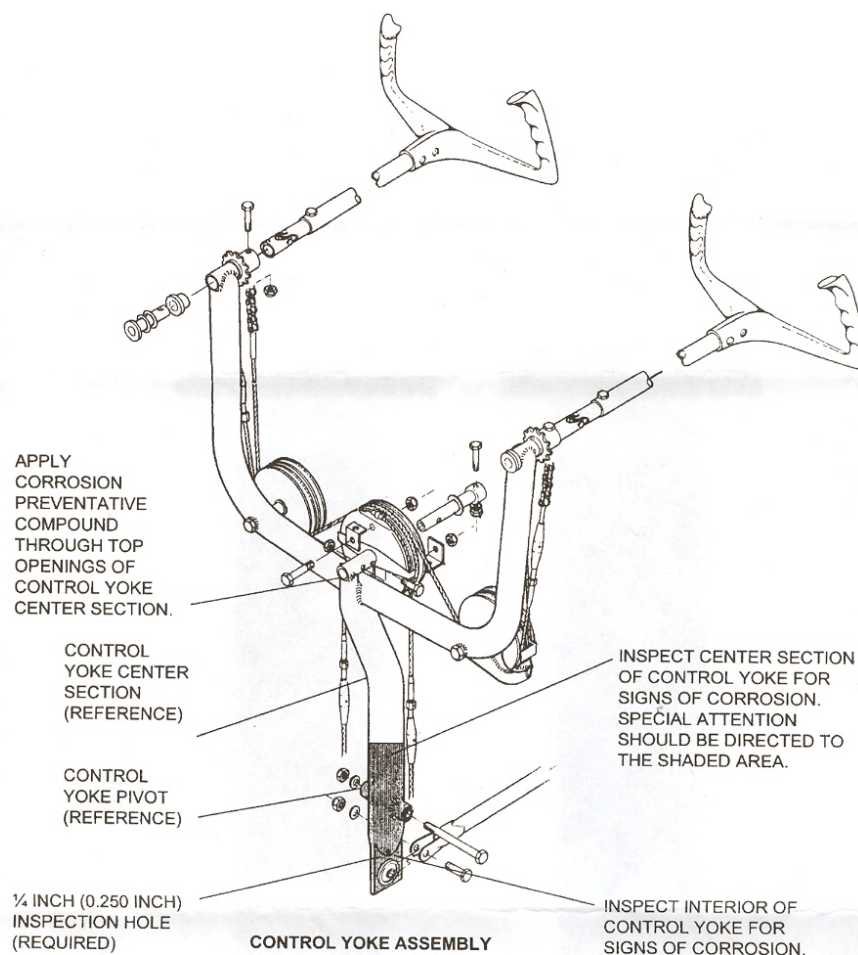
Figure 1. Control Yoke Inspection

"The FAA recently proposed in a safety recommendation to issue an Airworthiness Directive to comply with Cessna SEB01-3R1. The purpose for this service bulletin is given as follows: 'Reports have been received of some control yokes corroding internally resulting in failure of the control yoke below the pivot attach point. The control yoke shall be inspected, and if required, replaced as described in this service bulletin. Non-compliance with this service bulletin may result in failure of the control yoke which could cause complete loss of elevator control.'

"The safety recommendation was issued because of a reported failure of a control yoke that was found while complying with the service bulletin on a 1985 Cessna 172P in Anchorage, Alaska during April 2008. As shown in the photograph, the drain hole appears to be larger than ¼ inch diameter and is mislocated. The correct position is shown in the enclosed Figure 1 from page 11 of SEB01-3R1. The FAA has determined that this alteration from the service bulletin weakened the tube structure, and may have contributed to the failure.

"For additional information on maintaining the control yokes, we suggest that you review the FAA Special Airworthiness Information Bulletin (SAIB) CE-04-03, Cessna Service Bulletin SEB01-3R1, and the article published in the Cessna Pilot Association (CPA) in September 2002 on pages 6308 through 6311 entitled 'CPA Comments to the Airworthiness Concern Sheet dated 5/31/02'."
